DEPARTMENT OF TRANSPORTATION

Contract #: 04-0120F4Cty: SF/ALA Rte: 80 PM: 13.2/13.9File #: 69.28**WELDING INSPECTION REPORT****Resident Engineer:** Pursell, Gary**Address:** 333 Burma Road**City:** Oakland, CA 94607**Report No:** WIR-006083**Date Inspected:** 25-Feb-2009**Project Name:** SAS Superstructure**OSM Arrival Time:** 645**Prime Contractor:** American Bridge/Fluor Enterprises, a JV**OSM Departure Time:** 1845**Contractor:** Zhenhua Port Machinery Company, Ltd (ZPMC), Changxing Island **Location:** Shanghai, China**CWI Name:** See Below**CWI Present:** Yes No**Inspected CWI report:** Yes No N/A**Rod Oven in Use:** Yes No N/A**Electrode to specification:** Yes No N/A**Weld Procedures Followed:** Yes No N/A**Qualified Welders:** Yes No N/A**Verified Joint Fit-up:** Yes No N/A**Approved Drawings:** Yes No N/A**Approved WPS:** Yes No N/A**Delayed / Cancelled:** Yes No N/A**Bridge No:** 34-0006**Component:** Tower Fabrication**Summary of Items Observed:**

WELDING INSPECTION REPORT

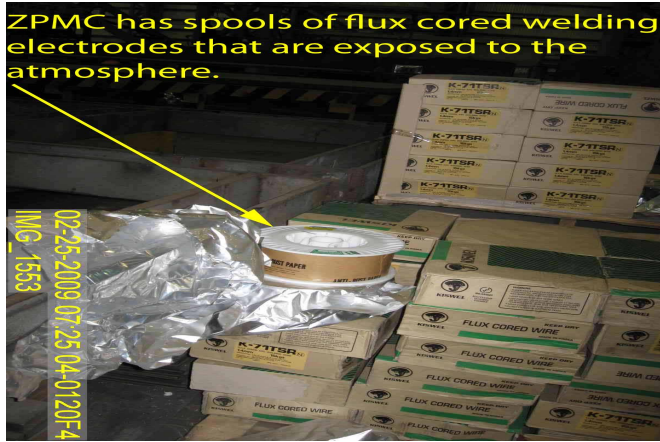
The QA Inspector performed random visual inspection of the flux cored welding electrode storage location in near the center of heavy tower bay #10 and the QA Inspector observed ZPMC has one roll of flux cored welding electrode which has had the air tight protective cover removed from the spool of electrode material. The QA Inspector informed ABF and QC personnel this type of electrode should remain in the hermetically sealed

packaging until this material is ready for use, and this welding electrode was discarded. Note: AWS D1.5 paragraph 12.6.7.2 states: "Electrode Packaging. FCAW and GMAW (metal cored) electrodes shall be received in moisture-resistant packages that are undamaged. They shall be protected against contamination and injury during shipment and storage. Electrode packages shall remain effectively sealed against moisture until the electrode is required for use." See the photograph below for additional information.
